SCOTT RIVER
LANDOWNER RIPARIAN PLANTING PROJECT:
A RIPARIAN IMPROVEMENT PROJECT
AGREEMENT # 14-48-11333-00-J001
PROJECT IDENTIFICATION # 2000-HR-03

Project completed on 2/15/01, by:
Siskiyou Resource Conservation District
Gary Black
PO Box 268
Etna, CA 96027
Telephone # (530) 467-3975
Fax # (530) 467-5617

PROJECT ACCOMPLISHMENTS, SITE DESCRIPTIONS AND RESULTS:

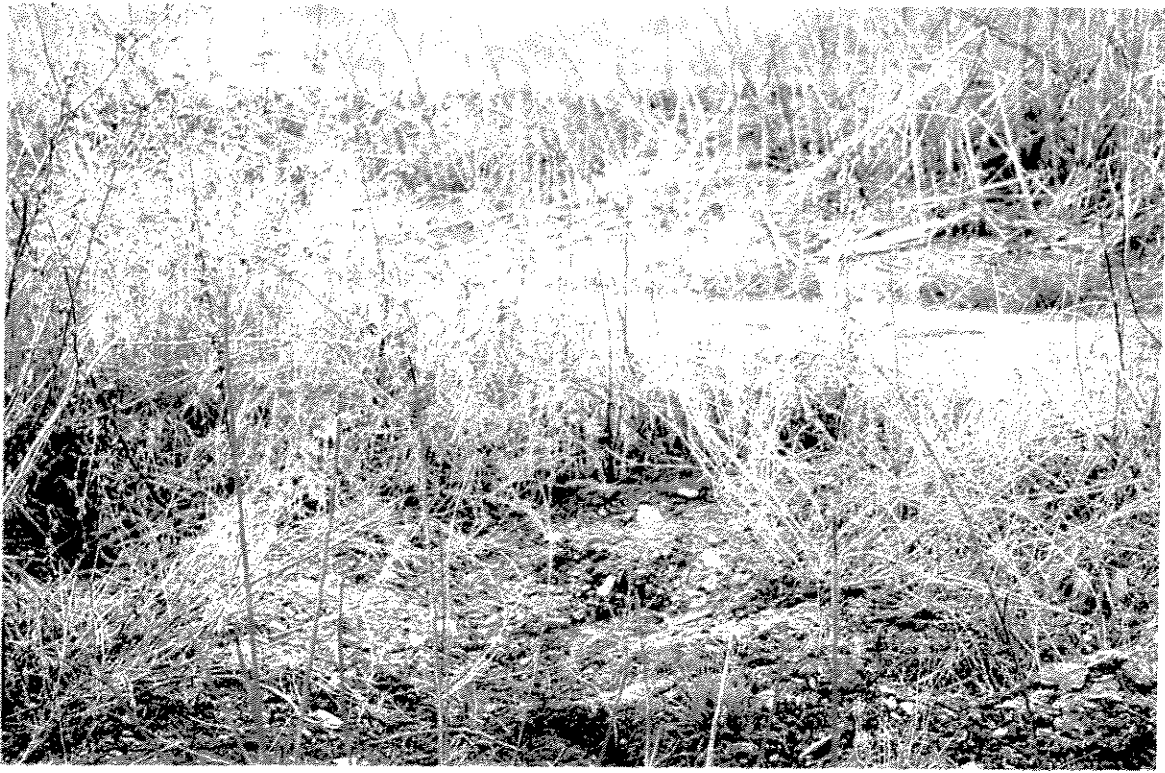
Site #1: Photo of typical surviving trees after one growing season. Notice deer browse has occurred but has not been severe.

Wildlife Affects: The site supports a fair population of deer which summer along the Scott River and feed in the fields. Some browsing did occur but it was not significant. Beaver enjoyed the plantings near Indian Creek but the damage affected less then 25% of the site.

Post Planting Evaluation: We achieved a little less then average success at this main stem site and along Indian Creek. On the main stem, we feel the difficulty of the site combined with a dry, early summer which lasted until October, stressed the plants to the point of poor survival. The survival rates on the main stem was 64% and the average vigor (scale of 1 to 5, 5 being great growth) rating was 2.3. The Indian Creek planting's survival rate was 59% survival rate and a vigor rate of 3.5. Poor stock seemed to be an issue on Indian Creek as one planting stretch showed little or no stem development or root development and composed nearly half of the trees which did not survive at the site.

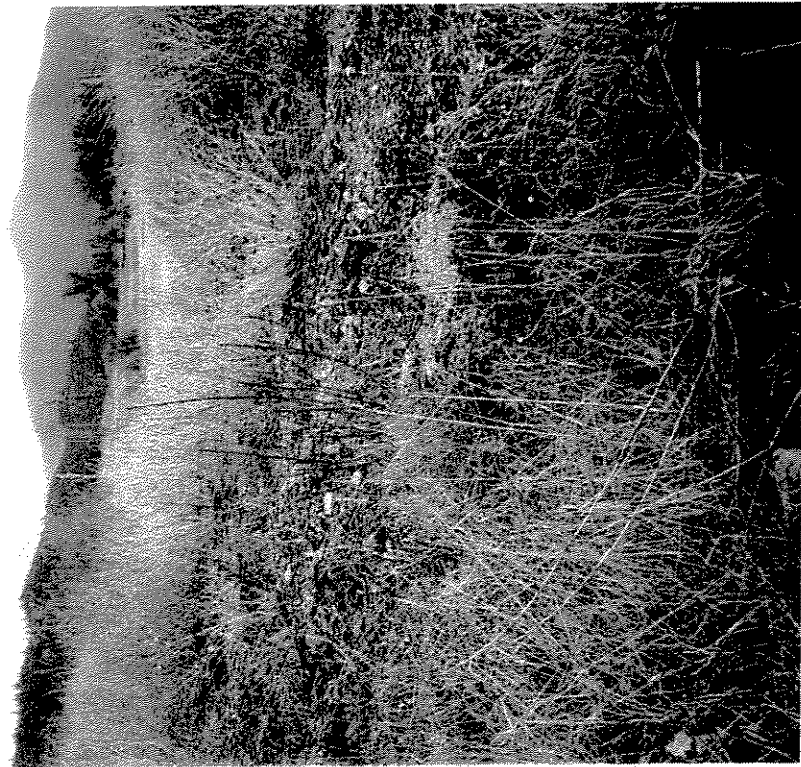
Site #2: Picture taken in the fall of cuttings which have not been browsed. Cuttings have one season of growth.

Post Planting Evaluation: The success at site #2 was impressive except for the small site on Patterson Creek site which has only 23% survival. The main site along the main stem of the Scott River responded well with a survival rate of 83% and a vigor rate of 3.5. 30% of the plantings which did not survive were grouped together in a site with good planting conditons. This leads us to believe poor planting stock was the issue again as little to no development occurred.

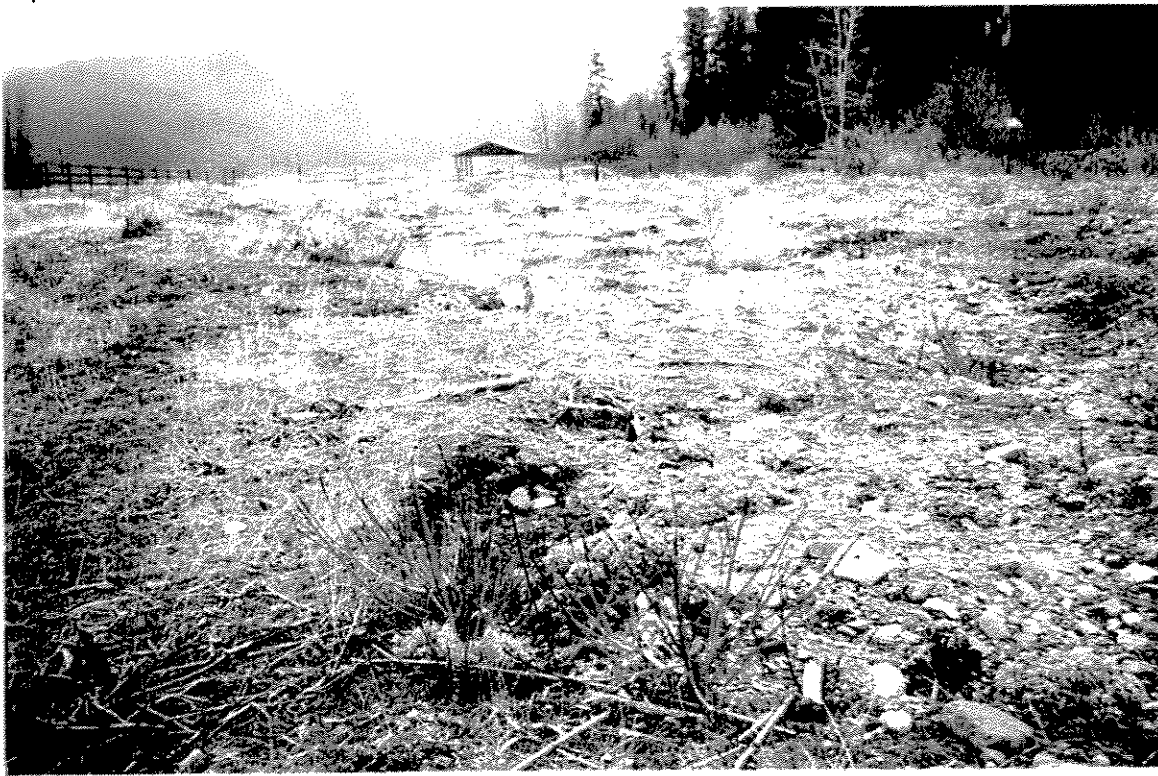
Site #3: Typical tree at site in the fall of 2000. One seasons growth

Wildlife Affects: Deer browsing or beaver damage was not an issue at this site. The trees grew well early in the year then slowed dramatically. In mid July, livestock entered the site and caused some damage to the trees, mostly by lying on them rather than grazing. The livestock damaged trees were already not performing well and the combination caused high mortality.

Post Planting Evaluation: Survival percentage was only 56% for the site while vigor was only 1.5. Livestock had an impact, but it was not the only issue. While the site looked good and stock seemed to show development attempts, something was missing. The plantings were mulched to reduce heat damage and water table did not seem to be an issue, nor was competition. We are not sure why plantings were not doing well even before livestock entrance.

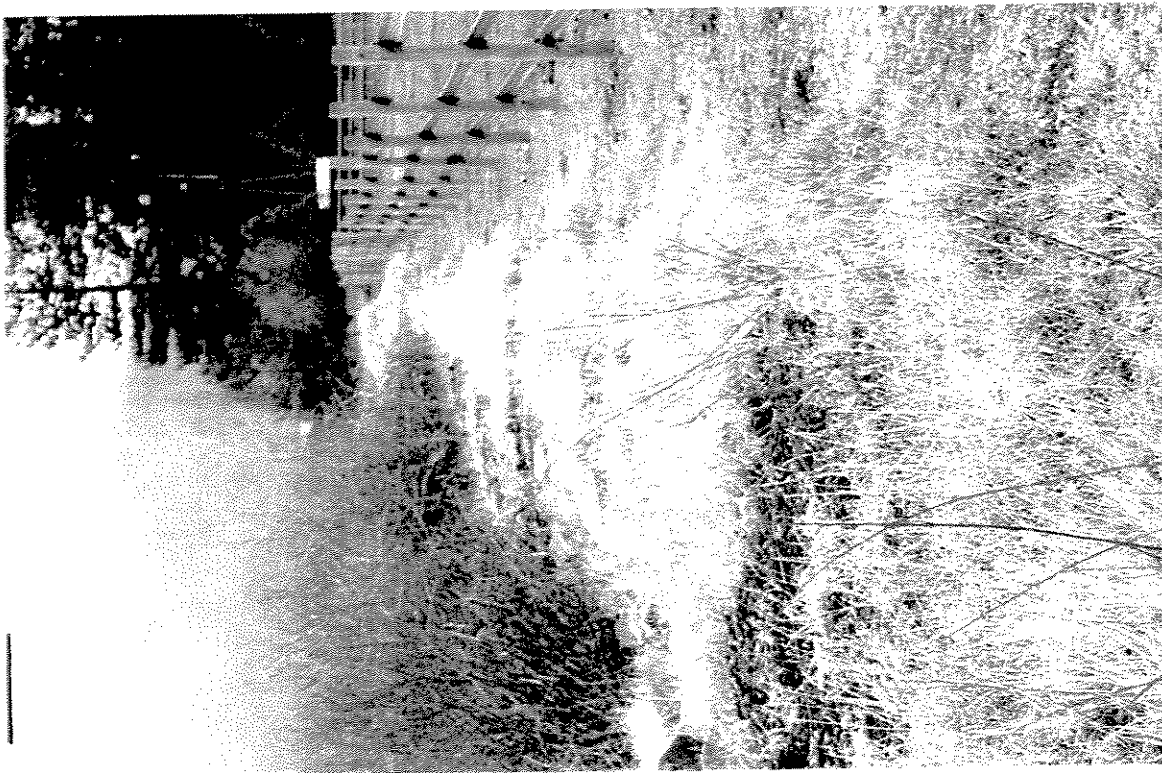
Site #4: Typical growth after one seasons of growth.

Wildlife Affects: Deer browsing was an issue late in the summer and fall when they had an impact on actual growth. Root strength should be solid and established for next season.

Post Planting Evaluation: The site performed fairly well. 80% of the cuttings survived through the first season. Vigor was poor, and it appeared many of the plantings had just limped throughout the difficult year. Vigor rating is only 1.7 and many of the trees had died back considerably and were browsed heavily. Maintenance and mulching

pulled many of the trees through the season. Native riparian vegetation died back at this site as well. Water availability appeared to be a limiting factor at this site.

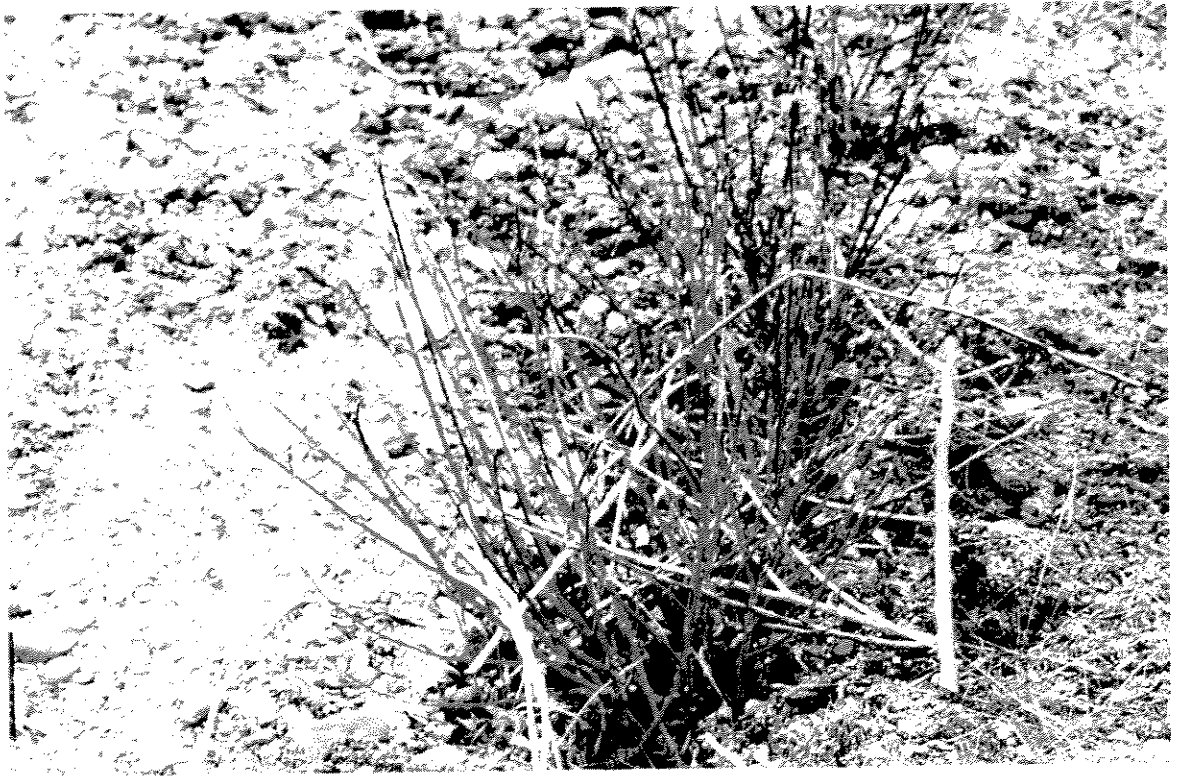
Site # 5: Typical tree at site #5. Photo taken after one season of growth.

The site did extremely well as did the opposite side of the creek last year. Survival percentage was 96% and the vigor rating was 3.7. Moffet Creek has work well for riparian plantings. The landowner is committed to the project and provides maintenance much better then the other participants. The trees are irrigated via irrigation sprinklers, which has helped with vigor and survival.
